Facility Master Plan

Malheur National Forest

December 2017 - DRAFT

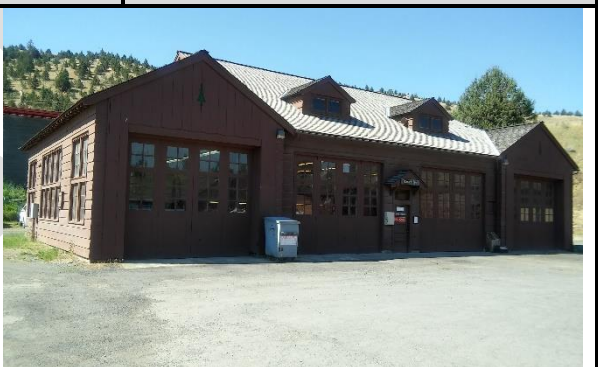
JOHN DAY COMPOUND - AUTO SHOP					2100
Recommendation:		Retain for Existing Use

GSF	CRV	DM	COND	YR CONST	
8240	\$1,604,180	\$0	GOOD	1937	
Other:

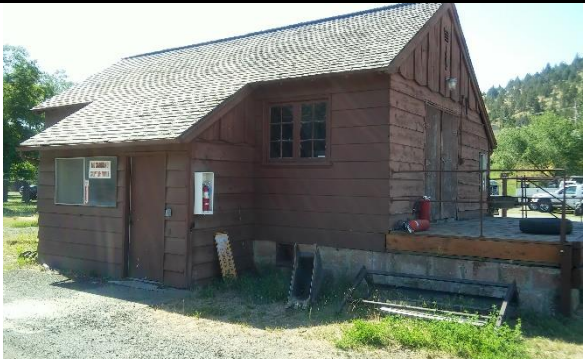
JOHN DAY COMPOUND - GAS HOUSE					2500
Recommendation:		Retain for Existing Use

GSF	CRV	DM	COND	YR CONST	
562	\$191,085	\$0	GOOD	1937	
Other:

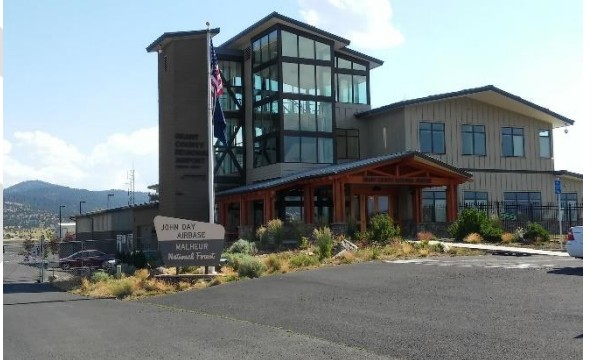
GRANT COUNTY JOINT AIRBASE FACILITY					5508
Recommendation:		Retain for Existing Use

GSF	CRV	DM	COND	YR CONST	
23876	\$6,448,597	\$0	GOOD	2009	
Other:

- Continue to manage this facility for existing use under the terms of the agreement with the County
- Evaluate options for providing a saw shop at the site using a prefab metal building

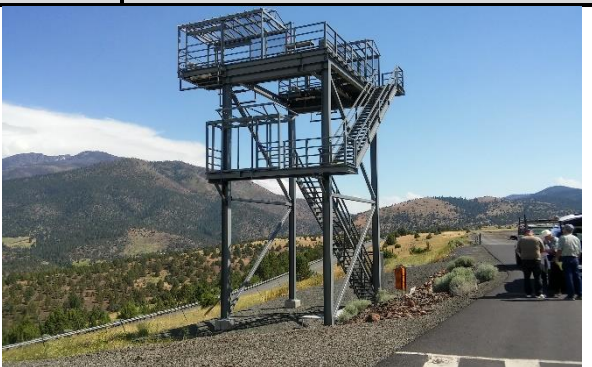
JOHN DAY HELIPORT - STEEL RAPPEL TOWER					4217
Recommendation:		Retain for Existing Use

GSF	CRV	DM	COND	YR CONST	
364	\$95,317	\$0	GOOD	2001	
Other:

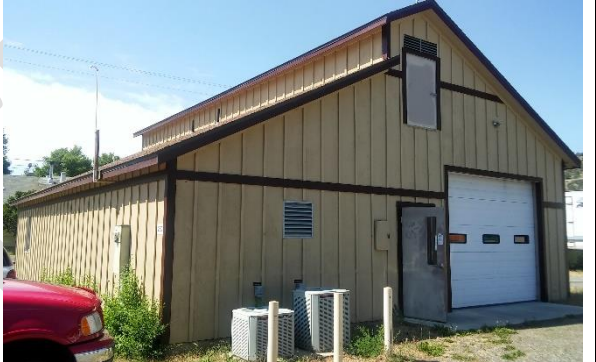
COMMUNICATIONS SHOP					2103
Recommendation:		Retain for Existing Use

The communications shop building is in the center of John Day on a city lot. The building provides workspace for radio installations and maintenance by the Forest radio technicians. The building is fully accessible and is good condition.

GSF	CRV	DM	COND	YR CONST	
1728	\$336,411	\$0	GOOD	1993	
Other:

Determine if there is adequate room to place a modular bunkhouse on this property

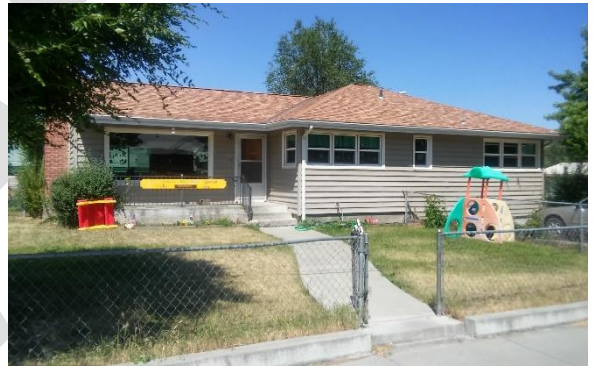
The Day Care Center is in a government owned residence (#1043) in downtown John Day. There are other day care options in John Day but none of them accept children under 3- 4 years of age. The day care operation has difficulty retaining qualified care givers and the Forest is working with the local hospital and county to establish a more stable arrangement. The day care has been upgraded to provide safe and healthy facilities except for emergency egress.

JOHN DAY – RESIDENCE (DAY CARE)				1043
Recommendation:		Retain for Existing Use*		
GSF	CRV	DM	COND	YR CONST
2912	\$606,838	\$0	GOOD	1963
Other: Currently used as daycare center but consider moving into vacant SO space and converting this building to a bunkhouse

- Evaluate the option of locating the day care in the leased SO in vacant space on the first floor of the east wing where there is a separate entrance and convert the existing day care residence to employee housing or bunkhouse space
- Continue working with the hospital and other local agencies that need daycare services to share in the financial support for use of this space as a multi-agency daycare center

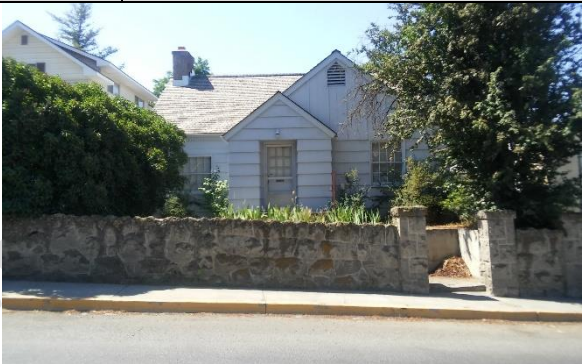
JOHN DAY – RESIDENCE					1001
Recommendation:		Retain for Existing Use

GSF	CRV	DM	COND	YR CONST	
1734	\$361,352	\$0	GOOD	1938	
Other: Used as a volunteer house

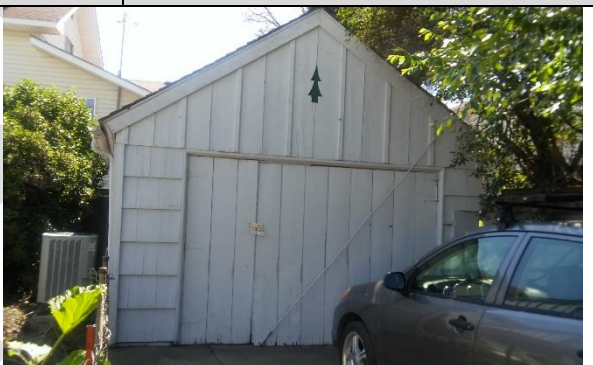
JOHN DAY - GARAGE					1500
Recommendation:		Retain for Existing Use

GSF	CRV	DM	COND	YR CONST	
299	\$40,993	\$0	GOOD	1939	
Other: Volunteer house garage

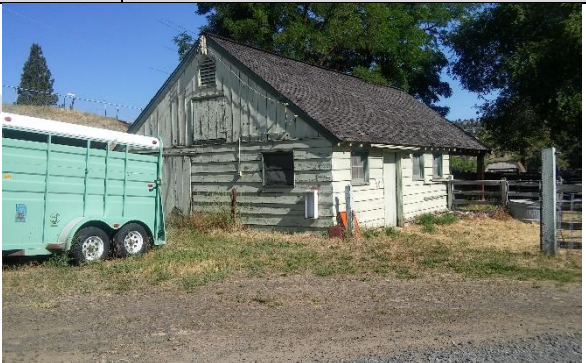
JOHN DAY COMPOUND - BARN				2400
Recommendation:		Retain for Existing Use		
GSF	CRV	DM	COND	YR CONST
875	\$119,963	\$0	GOOD	1937
Other: Consider re-purposing this building for storage

- Retain all buildings for existing use except for the barn (#2400) which either needs to be repaired and repurposed for use as storage or allow to "melt" in place

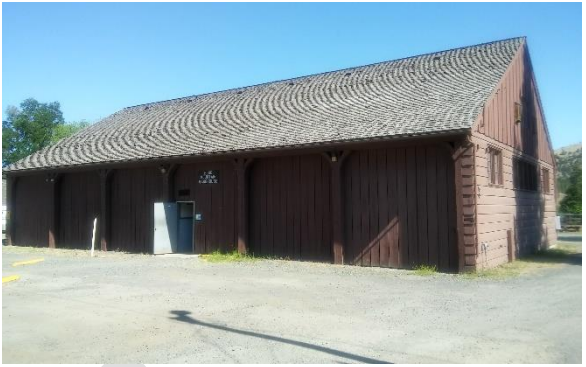
JOHN DAY COMPOUND - WAREHOUSE				2300
Recommendation:		Retain for Existing Use		
GSF	CRV	DM	COND	YR CONST
7960	\$1,549,669	\$131,728	FAIR	1938
Other:

- There is an old wheelchair or freight lift at the rear of building #2301 that may be adequate for wheelchair access to the main floor level of the warehouse but this needs to be evaluated for safety and reliability and replaced if not adequate or consider a pre-fab ramp system on the front of the building that would not permanently compromise the historic character of the building

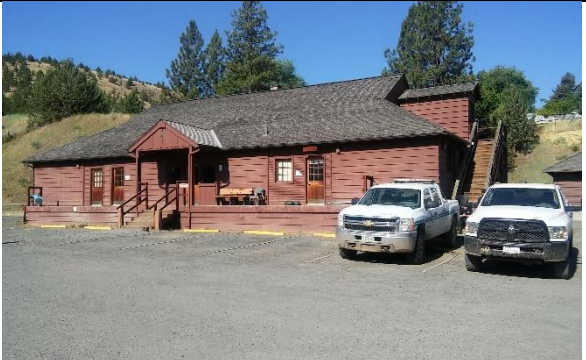
The residences are used for both transitional and permanent housing due to the lack of affordable housing in the area. The residences are often not used during the winter. The warehousing space does not have adequate restrooms for the number of employees assigned to work out of that space during fire season. The tree cooler is used only 4-5 weeks a year for tree storage except for replanting operations following major fire incidents. The barn is not being used except for miscellaneous storage. The fencing around the compound is failing and needs repairs. The major failure of the fence is behind warehouse building #2200 and includes a small slope failure of the over steepened bank which is about 25 feet high.

JOHN DAY COMPOUND - WAREHOUSE				2200
Recommendation:		Retain for Existing Use		
GSF	CRV	DM	COND	YR CONST
8696	\$2,348,677	\$0	GOOD	1938
Other:

- Consider placement of modular bunkhouses on this site to help with bunkhouse space shortage
- Request Geotechnical support to evaluate options for stabilizing the slope failure behind warehouse #2200 – repair the fence once the slope is stabilized

- Riprap the slope for stabilization or a combination of both buttressing and riprap
 - Determine if subsurface water is contributing to the slope failure and if so, provide a pathway for drainage away from the slope

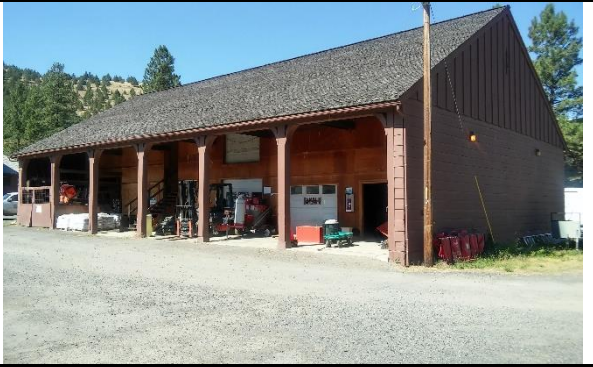
JOHN DAY COMPOUND - WAREHOUSE					2301
Recommendation:		Retain for Existing Use

GSF	CRV	DM	COND	YR CONST	
7960	\$1,549,669	\$0	GOOD	1936	
Other:

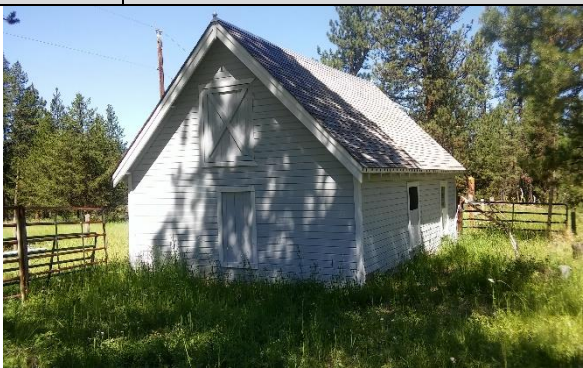
BLUE MOUNTAIN WC - BARN					2405
Recommendation:		Decommission

The barn (#2405) is situated below grade, has a rat infestation and is not used. The warehouse (#2206) is leaning and the doors are not plumb. The siding is rotting from snow and moisture at ground level and the paint is flaking. The upper loft has been used for storage but is not structurally adequate for any type of storage. The primary use for the warehouse is miscellaneous storage of tools and equipment.

GSF	CRV	DM	COND	YR CONST	
240	\$32,904	\$10,045	POOR	1931	
Other:

- If the barns are not viable or safe for use – consider preserving the exterior and allow the buildings to “melt”- if consultation with SHPO allows disposal after documentation – proceed with decommissioning

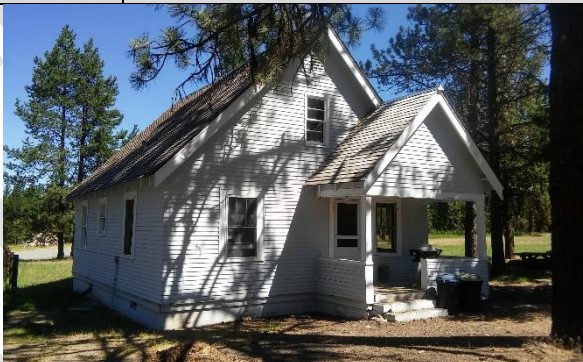
BLUE MOUNTAIN WC - BUNKHOUSE					2003	
Recommendation:		Decommission

The large residence (#1026) is vacant and not useable because of life/safety violations including asbestos containing materials, lead based paint, collapsed ceiling, electrical, plumbing issues and rodent problems. The small residence (#2003) is used by the fire engine captains for sleeping but also requires plumbing and electrical upgrades, smoke alarms, propane system upgrades and general repairs to meet livability standards.

GSF	CRV	DM	COND	YR CONST		
720	\$201,372	\$3,911	GOOD	1934		
Other:

- Evaluate remodeling small residence (#2003) to upgrade housing for the fire engine captains if no other viable options exist - decommission this building if alternative housing is found for the engine captains

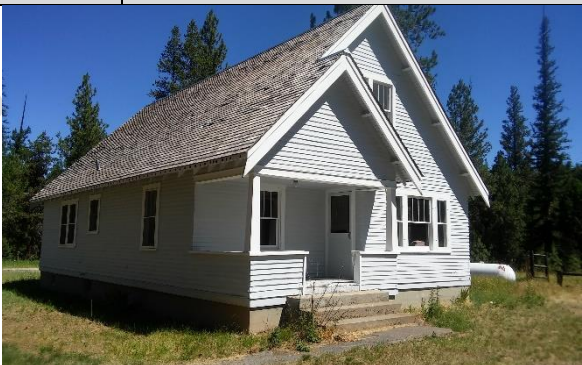
BLUE MOUNTAIN WC - BUNKHOUSE					1026
Recommendation:		Decommission

GSF	CRV	DM	COND	YR CONST	
1025	\$286,676	\$49,574	POOR	1933	
Other:

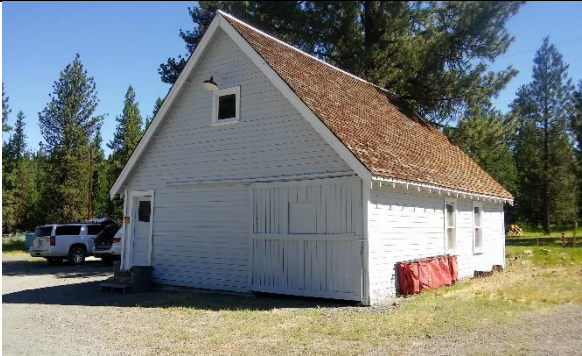
BLUE MOUNTAIN WC - WAREHOUSE					2206
Recommendation:		Decommission

GSF	CRV	DM	COND	YR CONST	
768	\$105,293	\$105,293	POOR	1932	
Other:

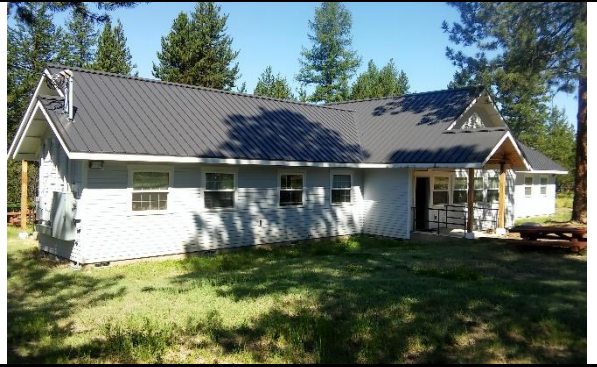
A new 14-person bunkhouse was constructed in 2011 to house fire crews and has separate wings for men and women. A stacked block retaining wall was started but not finished due to some constraints regarding historic context. The remaining 4 buildings (a warehouse, barn and two residences) were constructed in the 1930's and are in poor condition.

NEW BMWC BUNKHOUSE				1315
Recommendation:		Retain for Existing Use		
GSF	CRV	DM	COND	YR CONST
2499	\$698,930	\$0	GOOD	2011
Other:

- Develop a more proactive procedure for occupant check in and check out with third party inspections before and after occupancy to prevent degradation of the new bunkhouse

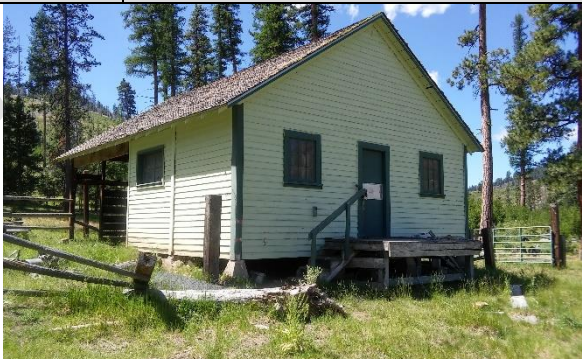
BVWC-BARN					2404
Recommendation:		Decommission

GSF	CRV	DM	COND	YR CONST	
1577	\$216,207	\$3,405	GOOD	1933	
Other:

- Trying to maintain one or two buildings at this site requires the repair and maintenance of a large water system that would be very costly both initially and annually – trying to maintain one or two buildings is not recommended
- Decommission the entire site using a salvage based contract to dispose of the buildings after clearance from SHPO is finalized
- Actively pursue a joint facility and fire staging area at Seneca, OR with the state and other entities to take advantage of shared fixed costs and eliminate any future need for staffing the Bear Valley work center

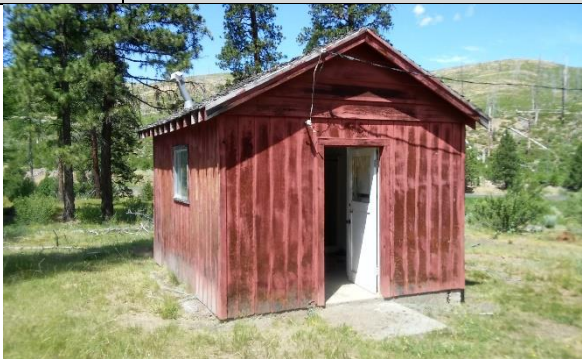
BVWC-BATH HOUSE					1701
Recommendation:		Decommission

GSF	CRV	DM	COND	YR CONST	
175	\$47,265	\$47,265	POOR	1954	
Other:

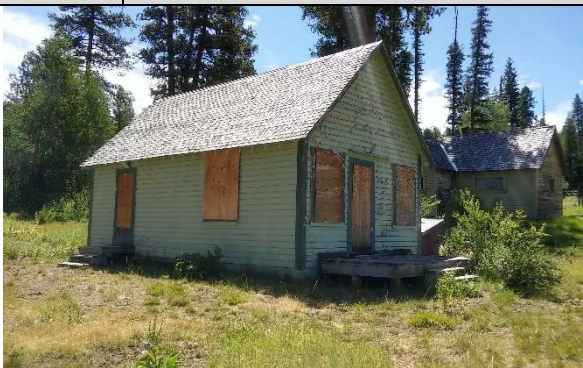
BVWC-BUNKHOUSE					2002
Recommendation:		Decommission

GSF	CRV	DM	COND	YR CONST	
459	\$62,929	\$62,929	POOR	1933	
Other:

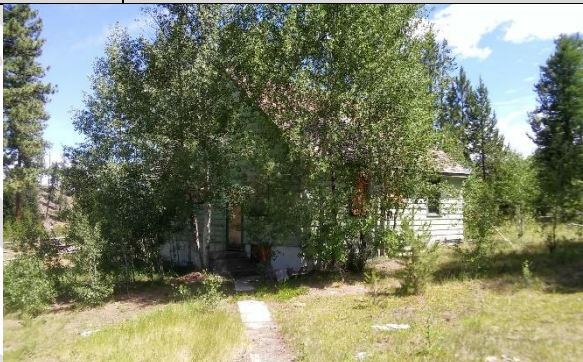
BVWC-BUNKHOUSE					1403
Recommendation:		Decommission

GSF	CRV	DM	COND	YR CONST	
1504	\$420,645	\$420,645	POOR	1933	
Other:

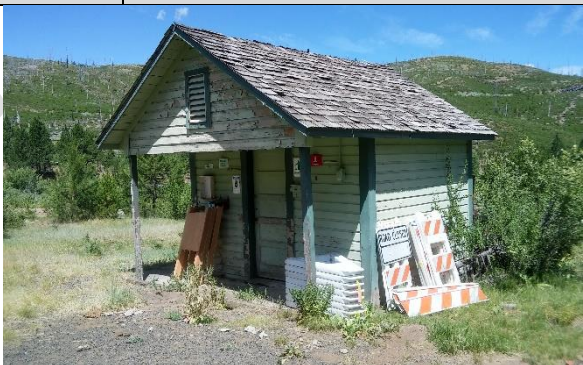
BVWC-GAS HOUSE				2504	
Recommendation:		Decommission

GSF	CRV	DM	COND	YR CONST	
126	\$42,841	\$3,167	FAIR	1933	
Other:

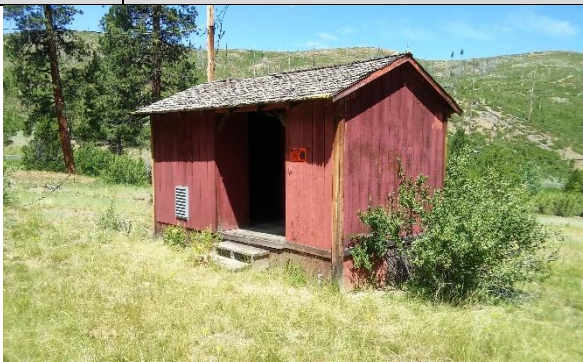
BVWC-GENERATOR HOUSE					1614
Recommendation:		Decommission

GSF	CRV	DM	COND	YR CONST	
118	\$40,121	\$40,121	POOR	1957	
Other:

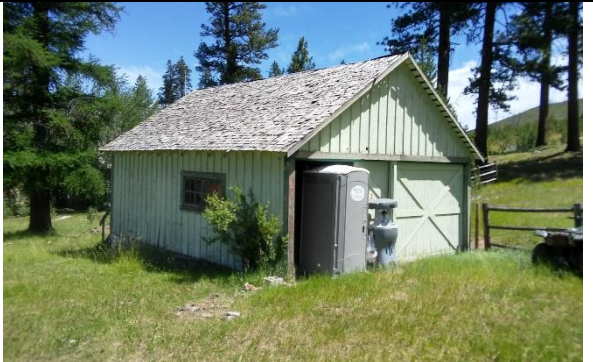
BVWC-STORAGE					1514
Recommendation:		Decommission

GSF	CRV	DM	COND	YR CONST	
577	\$79,107	\$79,107	POOR	1933	
Other:

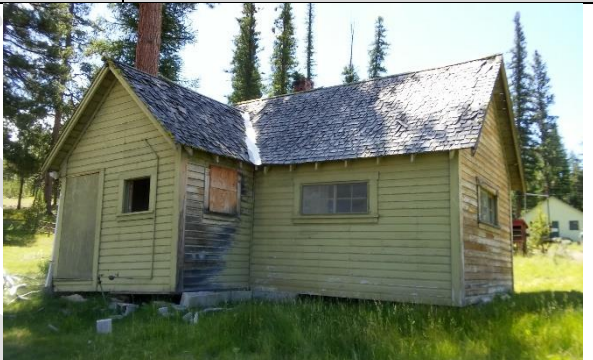
BVWC-HOUSE					1020
Recommendation:		Decommission

GSF	CRV	DM	COND	YR CONST	
425	\$58,268	\$58,268	POOR	1933	
Other: Add - moved from rec list

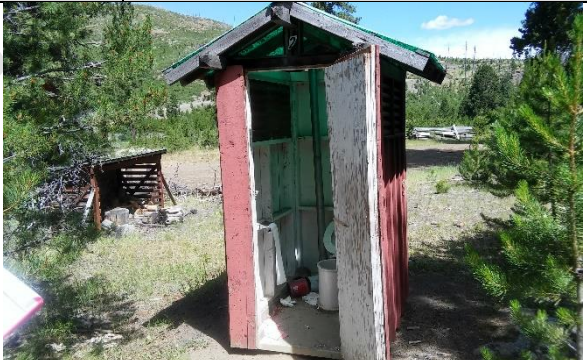
BVWC-TOILET					1720
Recommendation:		Decommission

GSF	CRV	DM	COND	YR CONST	
20	\$8,692	\$6,460	POOR	1946	
Other: Add - moved from rec list

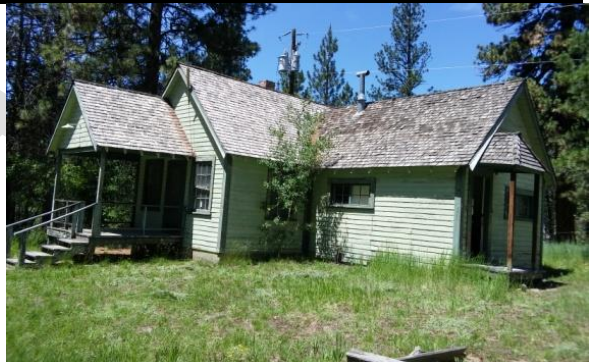
Raddue GS - Bunkhouse					1023
Recommendation:		Decommission

The Raddue Guard Station was considered as a potential recreation rental but is not viable due to the very poor condition, the rodent infestation and the historical significance has been compromised. The site has a bunkhouse, storage building and a toilet. The bunkhouse is made up of two buildings that were joined together in 1980. The garage was also moved to the current location at that time. The water system needs repairs and is not useable. The water system is located on private property to the east and water is shared with a private residence. The buildings and the water system are in disrepair. The buildings have broken windows, asbestos flooring, lead based paint, rat infestation and structural concerns. It is estimated it will require an investment of at least \$50,000 to make the bunkhouse safe and habitable. In 1980 trailer pads were constructed for YCC crew housing but were never used. The site was recommended for decommissioning in the 2010 FMP. The site has been cleared for disposal by SHPO.

GSF	CRV	DM	COND	YR CONST	
672	\$187,948	\$187,948	POOR	1933	
Other:

Move ahead with decommissioning this site.

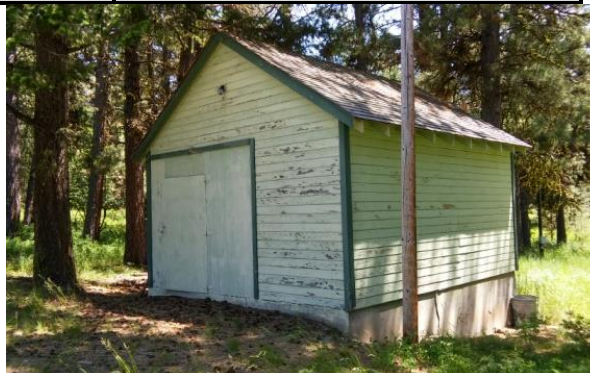
Raddue GS - Storage					1520
Recommendation:		Decommission

GSF	CRV	DM	COND	YR CONST	
288	\$26,060	\$26,060	POOR	1934	
Other:

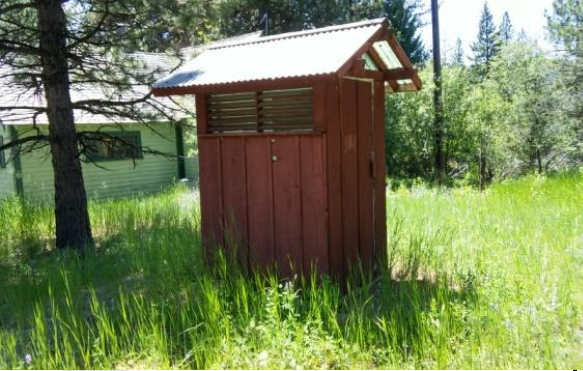
Raddue Forest Camp - Toilet					5511
Recommendation:		Decommission

GSF	CRV	DM	COND	YR CONST	
16	\$6,954	\$777	POOR	1962	
Other:

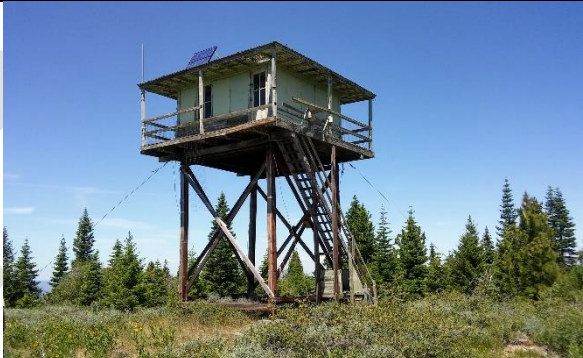
BLACK BUTTE - LO					4201
Recommendation:		Decommission

The Black Butte lookout is condemned because of safety concerns. The L-4 tower constructed in 1933 has been modified with treated timber legs. The lookout has been used during emergencies but is not routinely staffed. The cross bracing and some joists appear to be failing. The cab railing system is loose or missing in a few places. The stair railing is loose. The structure needs the guy wires tightened and the cab and stairs need paint. The propane system including piping and tank need upgrading. The lightning protection systems should be checked for continuity and reliability. The toilet located at the site is also in need of repair.

GSF	CRV	DM	COND	YR CONST	
400	\$104,744	\$66,661	POOR	1960	
Other:

- Decommission the lookout and toilet using a salvage based contract once SHPO clearances are finalized
- Due to the extensive repairs needed – this lookout is not recommended for use as a recreation rental

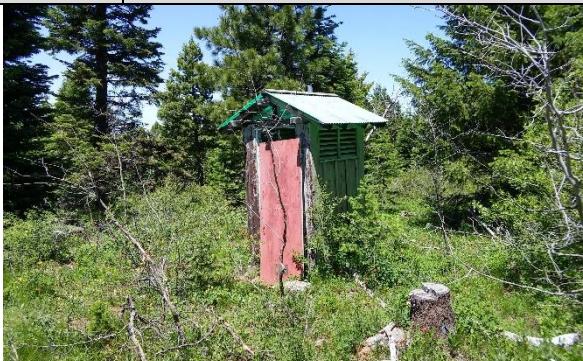
BLACK BUTTE-TOILET					1735	
Recommendation:		Decommission

GSF	CRV	DM	COND	YR CONST		
16	\$6,954	\$3,517	POOR	1954		
Other:

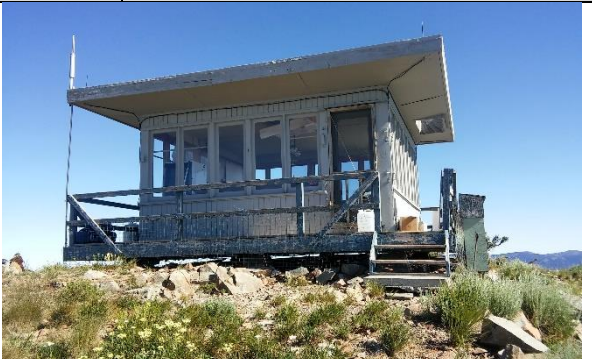
DIXIE BUTTE - LO				4009	
Recommendation:		Retain for Existing Use

The Dixie Butte lookout is a R-6 flat cab built in 1968. The lookout is staffed for about 4 months each fire season. The roof leaks and needs to be replaced. The guy wires need to be tightened. The lightning protection system should be checked for continuity and reliability. The propane system and tank need to be upgraded. There are two small toilets at the lookout site and the fiberglass toilet needs repairs. A communication building (#1617) at the site is a concrete block building in good shape. There is also a commercial communication building under special use on the site.

GSF	CRV	DM	COND	YR CONST	
465	\$121,765	\$48,200	POOR	1968	
Other:

- Complete an inspection of the lightning protection by a qualified contractor to ensure the safety of the system
- Replace the lookout flat roof with a membrane roof with a slight build up for drainage and suitable for the weather conditions (EPDM or similar material)
- Repair the door on the fiberglass toilet (#1738)
- Decommission the old wooden toilet (#1737) by removing it from the site
- Upgrade the propane system and tank
- Tighten the guy wires and repair any structure deficiencies

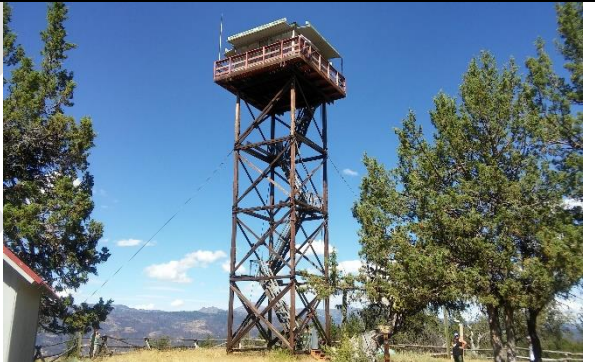
DRY SODA-LO					4202
Recommendation:		Retain for Existing Use

The Dry Soda lookout is an L-4 cab on a 50-foot treated timber tower built in 1941. The lookout is staffed for about 4 months during fire season. The lookout appears to be in fair shape. The guy wires are loose and a few cross-bracing members are split at the connections. The wood steps are cracking and several wood splices are suspect. The propane system needs upgrading. Two toilets are on the site. A newer CXT toilet in good condition and an old wooden toilet built in 1941 which is in poor condition and used for storage. A small storage building is also located at the site.

GSF	CRV	DM	COND	YR CONST	
400	\$104,744	\$0	GOOD	1941	
Other:

- Complete a structural inspection of the lookout and tower by a qualified structural engineer
- Complete an inspection of the lightning protection by a qualified contractor to ensure the safety of the system
- Upgrade the propane system and tank
- Tighten the guy wires and repair any structure deficiencies
- Decommission the old toilet (#1724) in place by not investing any further maintenance funds in this building

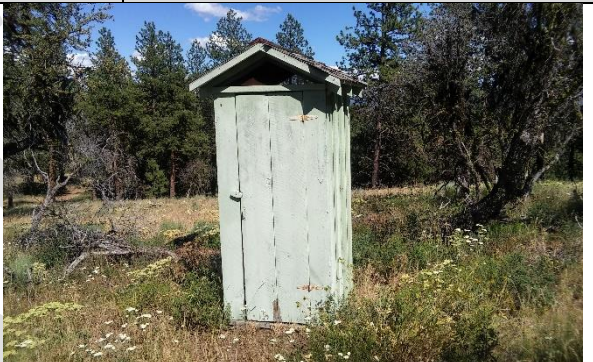
DRY SODA-TOILET					1724
Recommendation:		Decommission

GSF	CRV	DM	COND	YR CONST	
16	\$6,954	\$331	GOOD	1941	
Other:

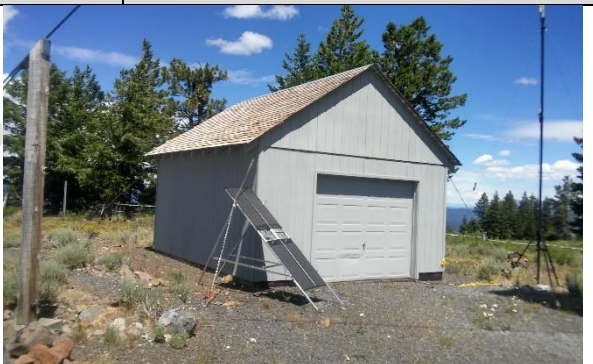
FLAGTAIL-GARAGE					1518
Recommendation:		Decommission

GSF	CRV	DM	COND	YR CONST	
289	\$39,622	\$5,522	POOR	1934	
Other:

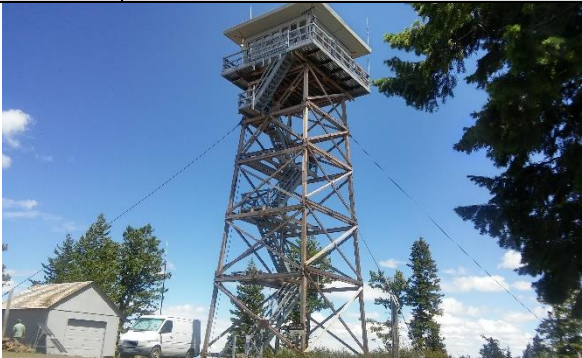
FLAGTAIL-LO				4204	
Recommendation:		Retain for Existing Use

The Flagtail lookout is a R-6 flat cab type on a 53-foot treated timber tower built in 1966. The lookout is staffed for about 4 months during fire season. The lookout is in fair shape. The stairs and cab need to be painted. The guy wires are loose and the propane system is substandard. There are two toilets at the site. A new CXT toilet was installed in 2010. The older wooden toilet was built in 1948. A garage built in 1934 is also located at the site. There appears to be asbestos tiles in the lookout cab floor.

GSF	CRV	DM	COND	YR CONST	
441	\$115,481	\$16,074	POOR	1966	
Other:

- Complete a structural inspection of the lookout and tower by a qualified structural engineer
- Complete an inspection of the lightning protection by a qualified contractor to ensure the safety of the system
- Upgrade the propane system and tank
- Tighten the guy wires and repair any structure deficiencies
- Decommission the old toilet (#1722) and garage (#1518) by removing and disposing
- Test and remove floor tiles if they contain asbestos and replace with similar floor tiles if available that don't contain asbestos
- Replace the lookout flat roof with a membrane roof with a slight build up for drainage and suitable for the weather conditions (EPDM or similar material)

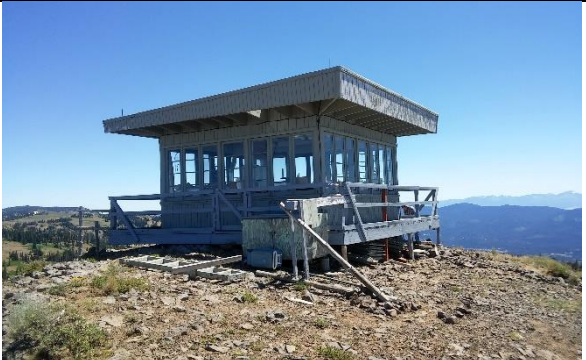
The Indian Rock lookout is R-6 flat cab sitting on pier blocks with no tower. The lookout is staffed for about 4 months during fire season. There is a question if this lookout is needed because of the proximity to other lookouts in the area and lookouts on the Wallowa Whitman NF which are nearby. The building is in poor condition. The guy wires and railing are loose. The building and the deck around the cab need painting and repairs. The flat roof should be replaced. The lightning protection system should be checked for continuity and reliability. The propane system and tank need to be upgraded. The quarter mile access trail up to the lookout is in poor condition and unsafe for walking and transporting supplies to the lookout.

INDIAN ROCK - LO				4013
Recommendation:		Retain for Existing Use		
GSF	CRV	DM	COND	YR CONST
240	\$62,847	\$20,402	POOR	1957
Other:

Evaluate the need for staffing this lookout considering fire coverage from other lookouts in the area – if it's determined not to be needed – decommission this lookout due to the extensive repair work needed - if it's determined the lookout is needed, the following is recommended:

- Complete a structural inspection of the lookout and tower by a qualified structural engineer
- Complete an inspection of the lightning protection by a qualified contractor to ensure the safety of the system
- Upgrade the propane system and tank
- Tighten the guy wires and repair any structure deficiencies
- Replace the lookout flat roof with a membrane roof with a slight build up for drainage and suitable for the weather conditions at a lookout (EPDM or similar material)
- Long term, consider replacing the compost toilet with a vault toilet to reduce maintenance and operation costs
- Design and construct a safe and pedestrian friendly access trail to the site with flatter grades and a tighter walking surface to eliminate injuries from slips and falls.

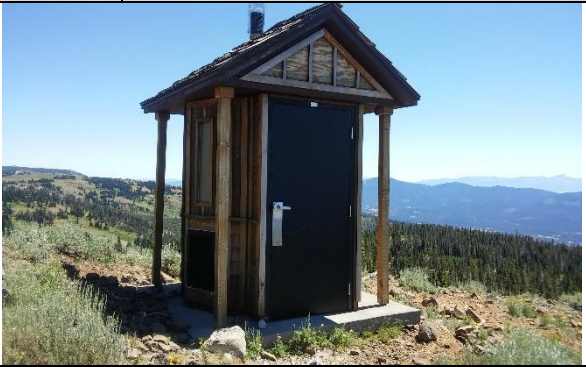
INDIAN ROCK LO TOILET					5296
Recommendation:		Retain for Existing Use

There is a Romtec toilet building on the site in fair condition. The toilet is a compost toilet that requires consistent and dedicated operator maintenance to function properly.

GSF	CRV	DM	COND	YR CONST	
40	\$17,384	\$324	GOOD	2004	
Other: This is a compost toilet

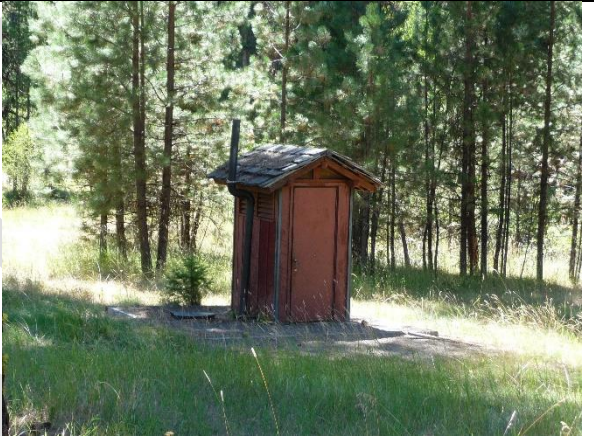
KEENEY CAMP GS-TOILET					5507
Recommendation:		Retain for Existing Use

This toilet is located at the old Keeney Camp Guard Station approximately 30 miles northeast of John Day, OR. The site is no longer used. The toilet is in fair condition. The roof and siding will need maintenance within the next 5 years.

GSF	CRV	DM	COND	YR CONST	
25	\$10,865	\$932	FAIR	1998	
Other:

Retain for existing use but consider decommissioning before spending maintenance funds

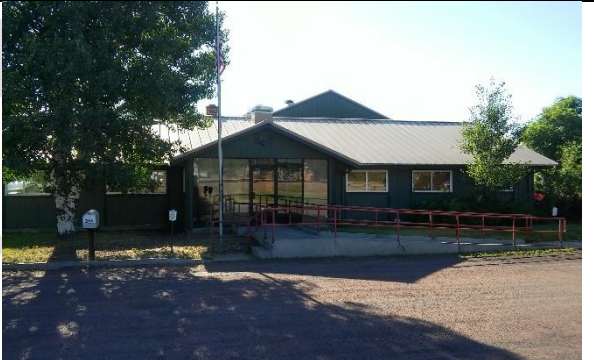
FRONT OFFICE					2004
Recommendation:		Retain for Existing Use

GSF	CRV	DM	COND	YR CONST	
2408	\$658,908	\$190,807	POOR	1962	
Other:

- Assign a number to the new office addition constructed in 2011 and confirm the size of the main office buildings
- Complete accessible parking improvements at the front office

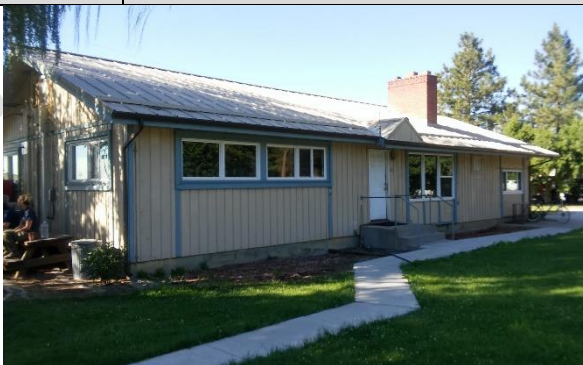
FIRE FUELS OFFICE					2008
Recommendation:		Decommission

Most employees are assigned space in the main office. GIS employees have office space in a separate shop building that has been remodeled to office space. There are 27 full-time fire employees assigned to 2 converted residences used as office space near the back of the compound. These two buildings are in deplorable condition and are severely overcrowded in the summer months.

GSF	CRV	DM	COND	YR CONST	
1860	\$508,957	\$508,957	POOR	1959	
Other:

- Implement the recommendations from the PPA completed in 2016 to address the inadequacy of the fire fuels and fire suppression office space plus additional reconfiguration of the site to accommodate a modern fire cache, staging and shower area, engine storage and training area

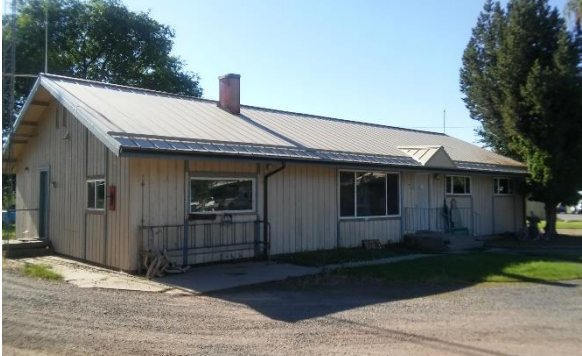
FIRE SUPPRESSION OFFICE					2009
Recommendation:		Decommission

GSF	CRV	DM	COND	YR CONST	
1860	\$508,957	\$508,957	POOR	1962	
Other:

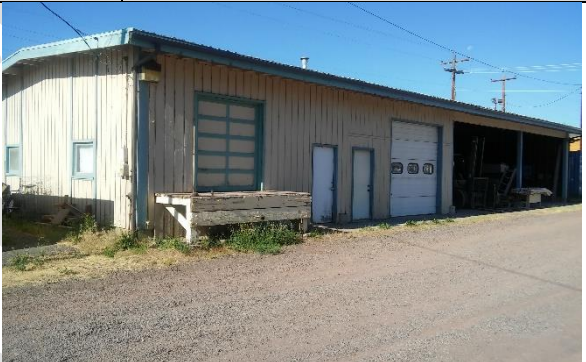
HEATED WAREHOUSE				2206
Recommendation:		Retain for Existing Use		
GSF	CRV	DM	COND	YR CONST
2400	\$333,360	\$46,446	POOR	1959
Other:

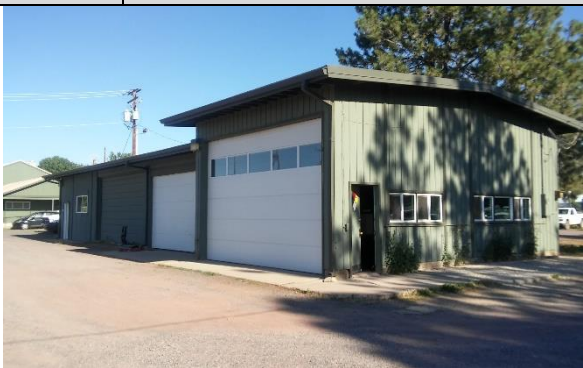
SHOP & GIS					2104
Recommendation:		Retain for Existing Use

GSF	CRV	DM	COND	YR CONST	
2460	\$485,205	\$103,238	POOR	1959	
Other:

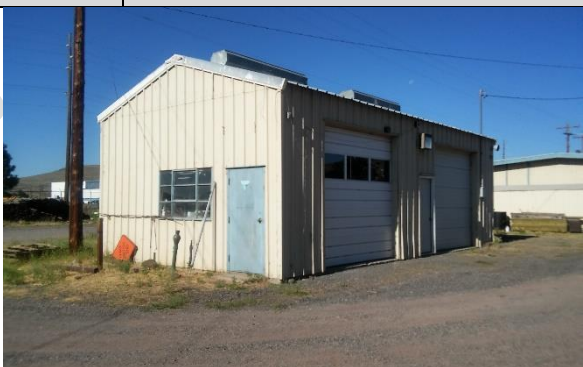
SNOW MTN REC & FIRE, TIRES					1400
Recommendation:		Retain for Existing Use

GSF	CRV	DM	COND	YR CONST	
720	\$100,008	\$10,565	POOR	1980	
Other:

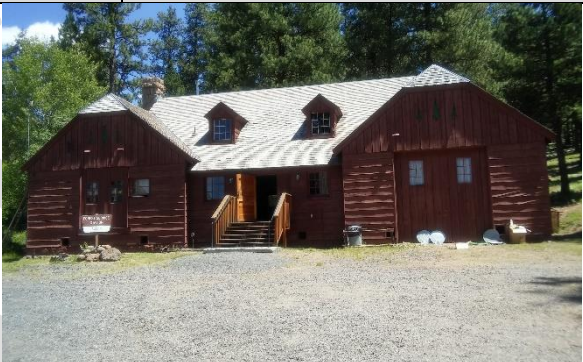
ALLISON BUNKHOUSE (REMODELED WAREHOUSE)					2201
Recommendation:		Retain for Existing Use

GSF	CRV	DM	COND	YR CONST	
2750	\$779,229	\$0	GOOD	1935	
Other: Major interior remodel in 2009 with ARRA funds to convert warehouse to bunkhouse

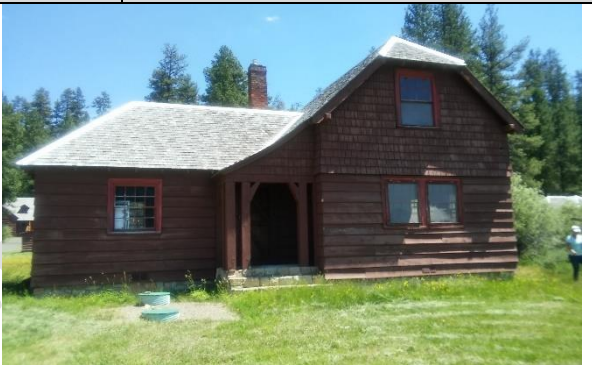
ALLISON COOKHOUSE					1301
Recommendation:		Retain for Alt Use - Rental

GSF	CRV	DM	COND	YR CONST	
954	\$201,416	\$12,835	FAIR	1935	
Other:

- Complete a sound business plan to determine the feasibility of using the two residences and the cookhouse for recreation rentals considering the cost to renovate the buildings and manage the site for both public and administrative fire use
- Evaluate the option of converting the wastewater treatment from a lagoon to a soil adsorption system such as drain-fields or mound system to reduce operation and maintenance costs and the requirement for a certified operator
- Continue to prioritize annual maintenance of the buildings to ensure the historic nature of the site is preserved

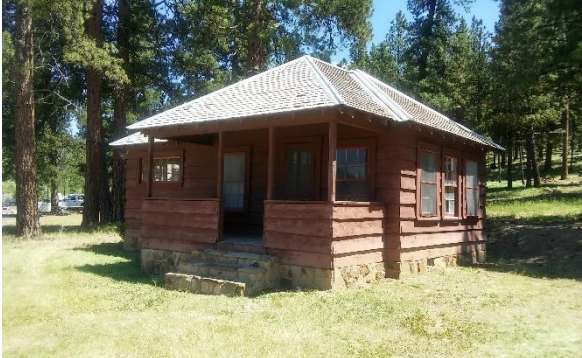
ALLISON SMALL RES					1152
Recommendation:		Retain for Alt Use - Rental

GSF	CRV	DM	COND	YR CONST	
499	\$105,353	\$16,820	POOR	1935	
Other:

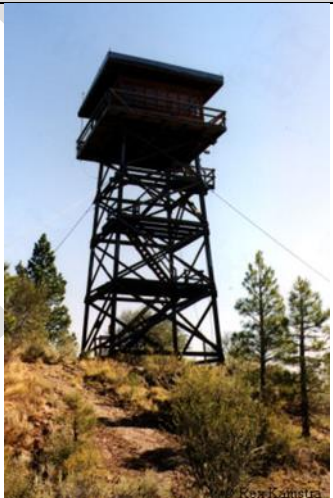
BALD BUTTE LOOKOUT					4216
Recommendation:		Decommission

The Bald Butte lookout is a R-6 flat cab on a 41-foot treated timber tower constructed in 1959. The lookout is not staffed and has not been used since the 1990's. Per discussion with fire staff with knowledge of the facility, the lookout has structural deficiencies and is condemned for safety reasons.

Decommission the lookout (#4216) using a salvage based contract

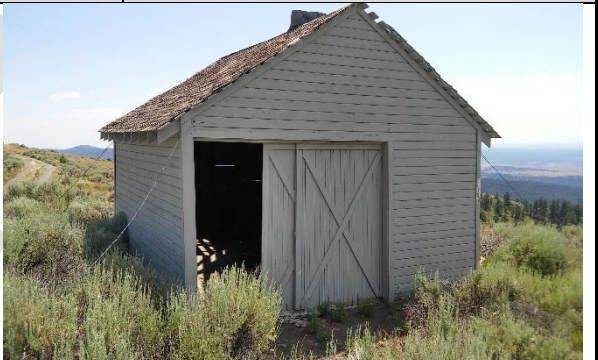
CALAMITY - GARAGE					1506
Recommendation:		Retain for Alt Use - Heritage

GSF	CRV	DM	COND	YR CONST	
624	\$86,674	\$27,309	POOR	1934	
Other: Retain as a heritage asset – allow to “melt”

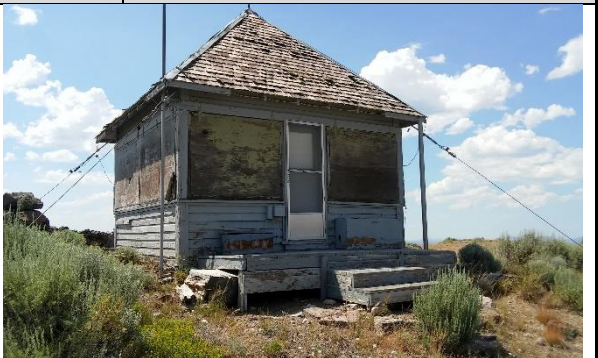
CALAMITY - LO				4003	
Recommendation:		Retain for Alt Use - Heritage			
GSF	CRV	DM	COND	YR CONST	
196	\$51,999	\$51,999	POOR	1927	
Other: Retain as a heritage asset – allow to “melt”

The Calamity lookout is an octagonal cab on a 50-foot treated round pole tower constructed in 2000. The lookout is staffed during fire season. An older lookout, R-5 cab (#4003) sits on the ground near the new lookout. The other two buildings at the site are a garage (#1506) and a wooden toilet (#1730). The old lookout, garage and toilet are in poor condition.

- Complete a structural inspection of the lookout and tower by a qualified structural engineer
- Complete an inspection of the lightning protection by a qualified contractor to ensure the safety of the system
- Upgrade the propane system and tank
- Tighten the guy wires and repair any structure deficiencies
- Replace the toilet building with a modern vault toilet
- Allow the garage and old lookout to “melt” into the ground by not investing scarce maintenance funds in either building

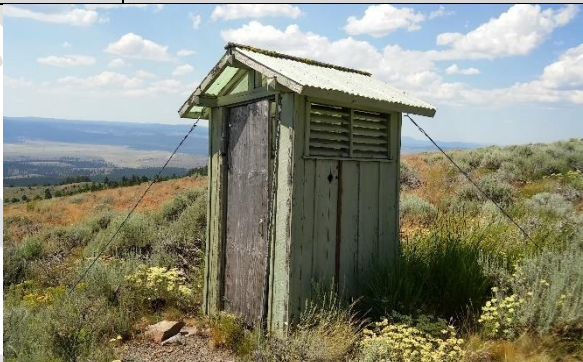
CALAMITY BUTTE-TOILET					1730
Recommendation:		Decommission

GSF	CRV	DM	COND	YR CONST	
16	\$7,045	\$11,474	POOR	1948	
Other: Decommission and replace with CXT

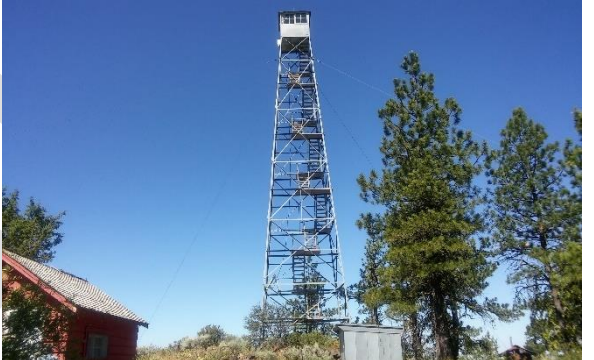
DRY MT LOOKOUT					4212
Recommendation:		Decommission

The Dry Mountain Lookout is a 7-foot by 7-foot cab on a 70-foot steel tower built in 1932. The lookout is no longer staffed. There is a ground house (cabin), a 7-foot by 8-foot metal communication building (not listed in the I-Web database) and a 4-foot by 4-foot wooden toilet (not listed in the I-Web database) at the site. The lookout stairs are deficient. The guy wires are loose. The ground house is infested with rats.

- Determine the status of the communications building to ensure it has active use and add it to the I-Web database
- Decommission the lookout, ground house and toilet by using a salvage based contract

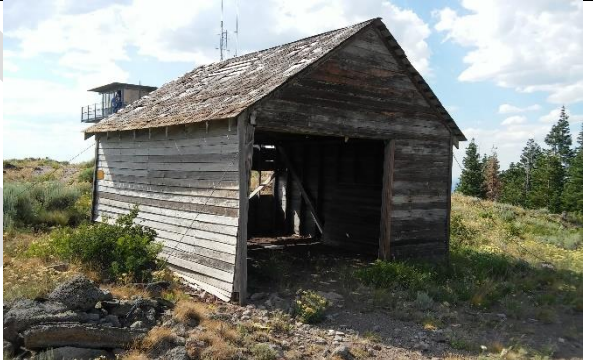
KING MOUNTAIN - GARAGE					1505
Recommendation:		Decommission

The King Mountain lookout is 13-foot by 13-foot steel cab on a 10-foot steel tower built in 1957. The lookout is no longer staffed. There site also has an old garage, a 10' x 10' communication building and a 6' x 6' communication building. There is also a commercial communication building under special use at the site. The lookout has hazardous stairs, decking, and railings. The garage is in disrepair with a poor roof and siding.

GSF	CRV	DM	COND	YR CONST	
300	\$41,670	\$36,077	POOR	1934	
Other:

- Decommission the lookout using a salvage based contract
- Allow the garage to “melt” into the ground by not investing scarce maintenance funds in the building

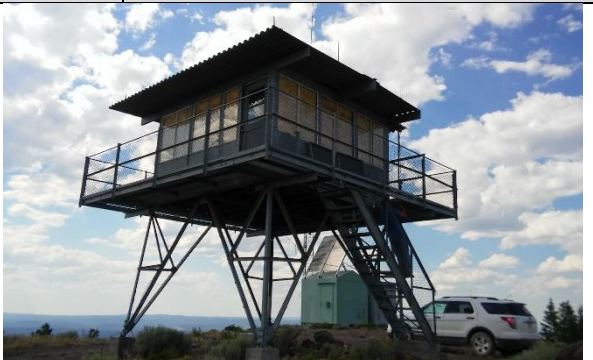
KING MOUNTAIN - LO				4213	
Recommendation:		Decommission

GSF	CRV	DM	COND	YR CONST	
178	\$47,223	\$39,005	POOR	1959	
Other:

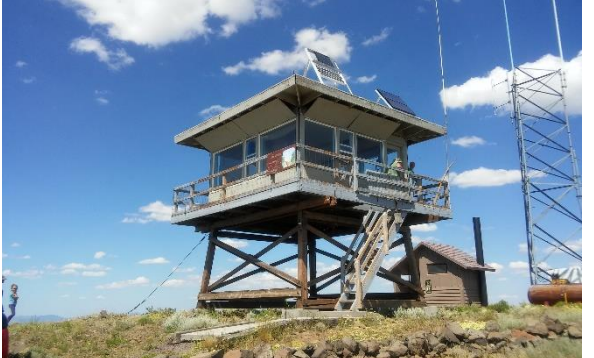
SNOW MT LOOKOUT					4350
Recommendation:		Retain for Existing Use

The Snow Mountain lookout is a R-6 flat cab on a 10-foot treated timber tower built in 1961. The lookout is staffed during fire season. The lookout has some deferred maintenance items including a leaking roof, loose railings, missing window screens, a crack in one footing, outdated propane system and need of painting. There are two other buildings at the site including a fiberglass communication building and a newer CXT toilet (not listed in the I-Web database).

GSF	CRV	DM	COND	YR CONST	
196	\$51,999	\$34,482	POOR	1961	
Other:

- Complete a structural inspection of the lookout and tower by a qualified structural engineer
- Complete an inspection of the lightning protection by a qualified contractor to ensure the safety of the system
- Upgrade the propane system and tank
- Tighten the guy wires and repair any structural deficiencies
- Replace the lookout flat roof with a membrane roof with a slight build up for drainage and suitable for the weather conditions (EPDM or similar material)
- Add the newer CXT toilet to the I-Web database

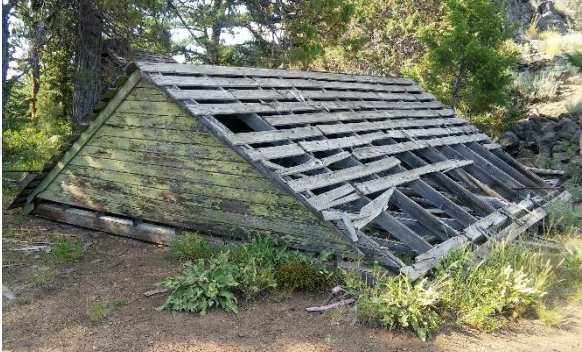
SUGARLOAF - GARAGE					1513
Recommendation:		Decommission

The Sugarloaf lookout has an L-4 cab on a 32-foot treated timber tower built in 1948. The lookout is staffed during fire season. The lookout is in poor condition with split cross members, loose guy wires, loose railing and outdated propane system. A garage and vault toilet building are also on site. The garage has collapsed with only the roof framing standing. The toilet building needs the roof treated, a new door and painting.

GSF	CRV	DM	COND	YR CONST	
295	\$40,976	\$40,976	POOR	1934	
Other:

- Determine the long-term need for the lookout and if possible decommission all buildings on the site using a salvage based contract - if the lookout remains in service, complete the following items
- Complete a structural inspection of the lookout and tower by a qualified structural engineer
- Complete an inspection of the lightning protection by a qualified contractor to ensure the safety of the system
- Upgrade the propane system and tank
- Tighten the guy wires and repair any structure deficiencies
- Replace the lookout flat roof with a membrane roof with a slight build up for drainage and suitable for the weather conditions (EPDM or similar material)

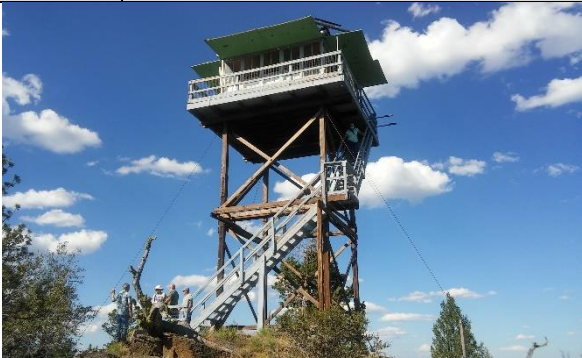
SUGARLOAF - LO				4208	
Recommendation:		Retain for Existing Use

GSF	CRV	DM	COND	YR CONST	
205	\$54,386	\$10,096	POOR	1948	
Other:

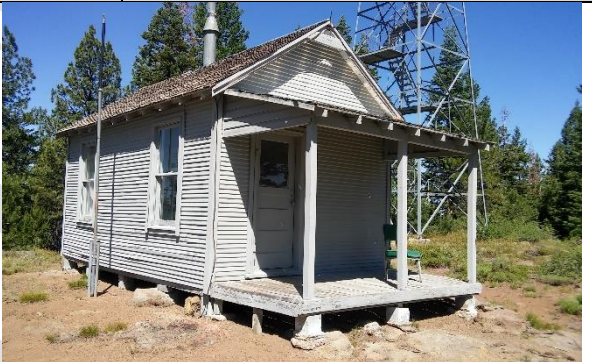
WEST MYRTLE - BUNKHOUSE					1511
Recommendation:		Decommission

The West Myrtle lookout is cab on a 60-foot tower built in 1929. The lookout is not staffed. The lookout is in poor condition with broken windows and vandalism to the structure. The other buildings at the site include two small bunkhouses and a pit toilet. All the buildings are in poor condition. There have been preliminary discussions to include the site in the recreation rental program. The cost to bring the buildings to a safe habitable standard will likely exceed \$100,000.

GSF	CRV	DM	COND	YR CONST	
288	\$81,607	\$22,842	POOR	1929	
Other:

Decommission all the buildings on the site using a salvage based contract

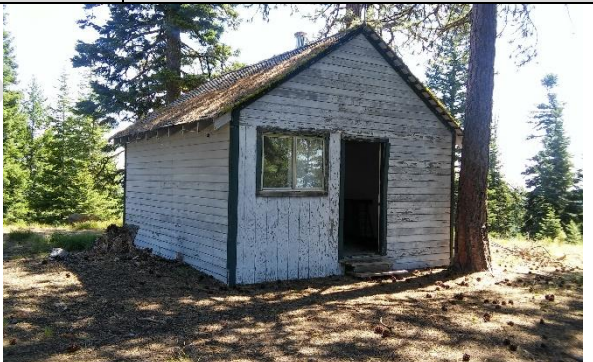
WEST MYRTLE - BUNKHOUSE					1017
Recommendation:		Decommission

GSF	CRV	DM	COND	YR CONST	
240	\$68,005	\$9,099	POOR	1929	
Other:

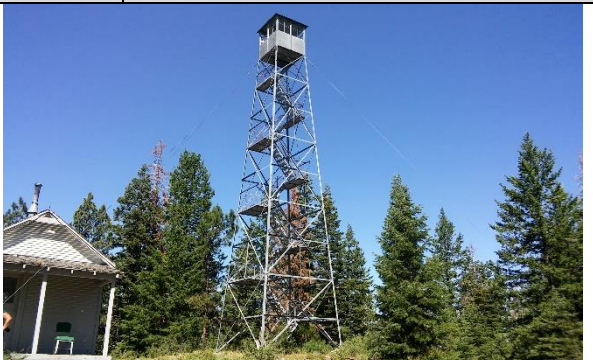
WEST MYRTLE - LO					4209
Recommendation:		Decommission

GSF	CRV	DM	COND	YR CONST	
49	\$13,000	\$10,741	POOR	1929	
Other:

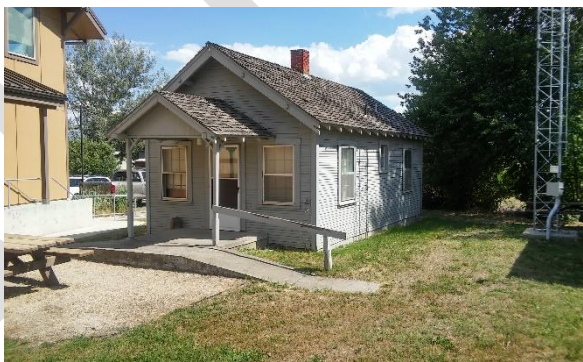
PRAIRIE CITY RS - RESIDENCE					1306
Recommendation:		Retain for Alt Use - Heritage			E

GSF	CRV	DM	COND	YR CONST	
448	\$125,298	\$28,782	POOR	1932	
Other: Currently used as quarters with quarters collections

- Determine if a visitor information contact point is needed – this would take additional staffing and the personnel at the front desk in the office are already providing this service – if this is not a viable option financially, consider decommissioning the residence (#1306) and the concrete block building unless a viable use can be found for these two facilities
- Evaluate expanding the parking area to the south and west to better facilitate public and employee parking
- Contract with an independent HVAC firm to determine if the building management system can be simplified to eliminate some of the issues with the complexity of the building control system

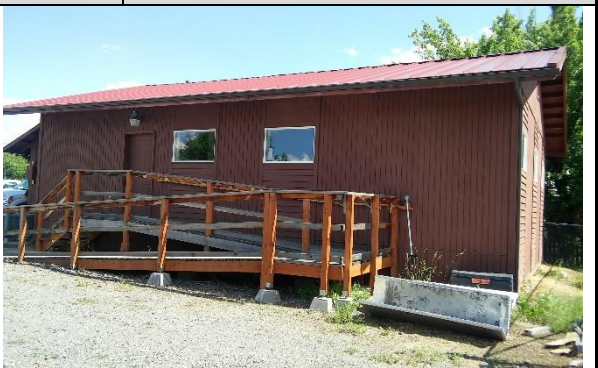
PCRD SEASONAL OFFICE					5530

Recommendation:		Retain for Existing Use				
GSF	CRV	DM	COND	YR CONST		
1250	\$337,609	\$0	GOOD	2011		
Other: Extend roof out over ramp to prevent snow and ice from accumulation on ramp

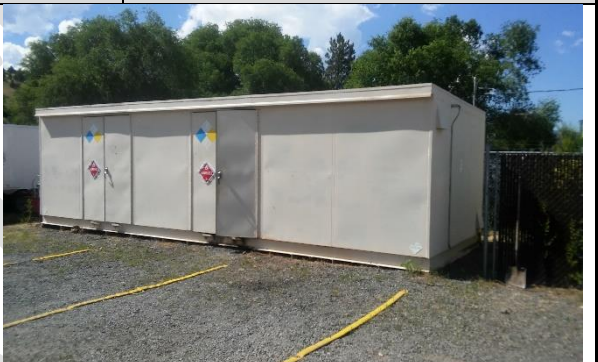
PRAIRIE CITY FLAMMABLE STORAGE					2325

Recommendation:		Retain for Existing Use				
GSF	CRV	DM	COND	YR CONST		
300	\$102,002	\$19,308	POOR	2003		
Other:

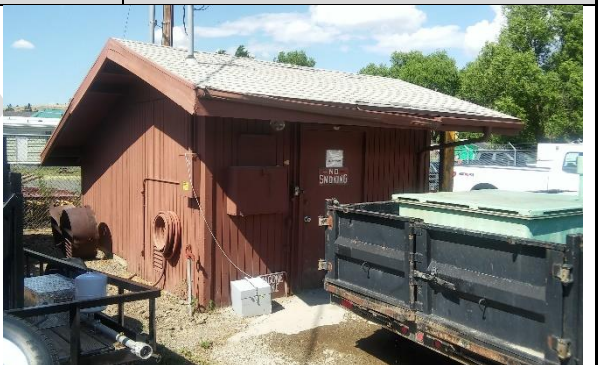
PRAIRIE CITY SC - GAS HOUSE					2508

Recommendation:		Retain for Existing Use				
GSF	CRV	DM	COND	YR CONST		
96	\$32,641	\$13,521	POOR	1973		
Other:

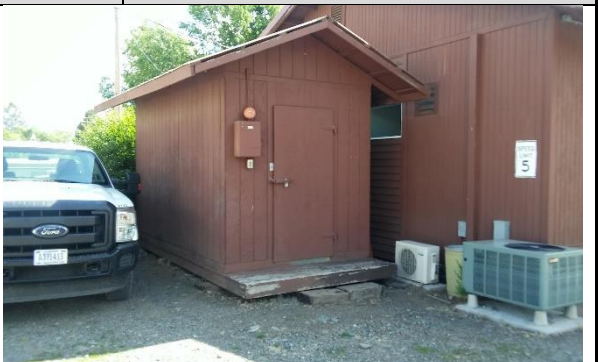
PRAIRIE CITY SC - TREE COOLER					2307

Recommendation:		Retain for Existing Use				
GSF	CRV	DM	COND	YR CONST		
112	\$38,081	\$15,509	POOR	1970		
Other:
